VIADUCT HARBOUR
MARINE EVENTS CENTRE

MOLLER ARCHITECTS

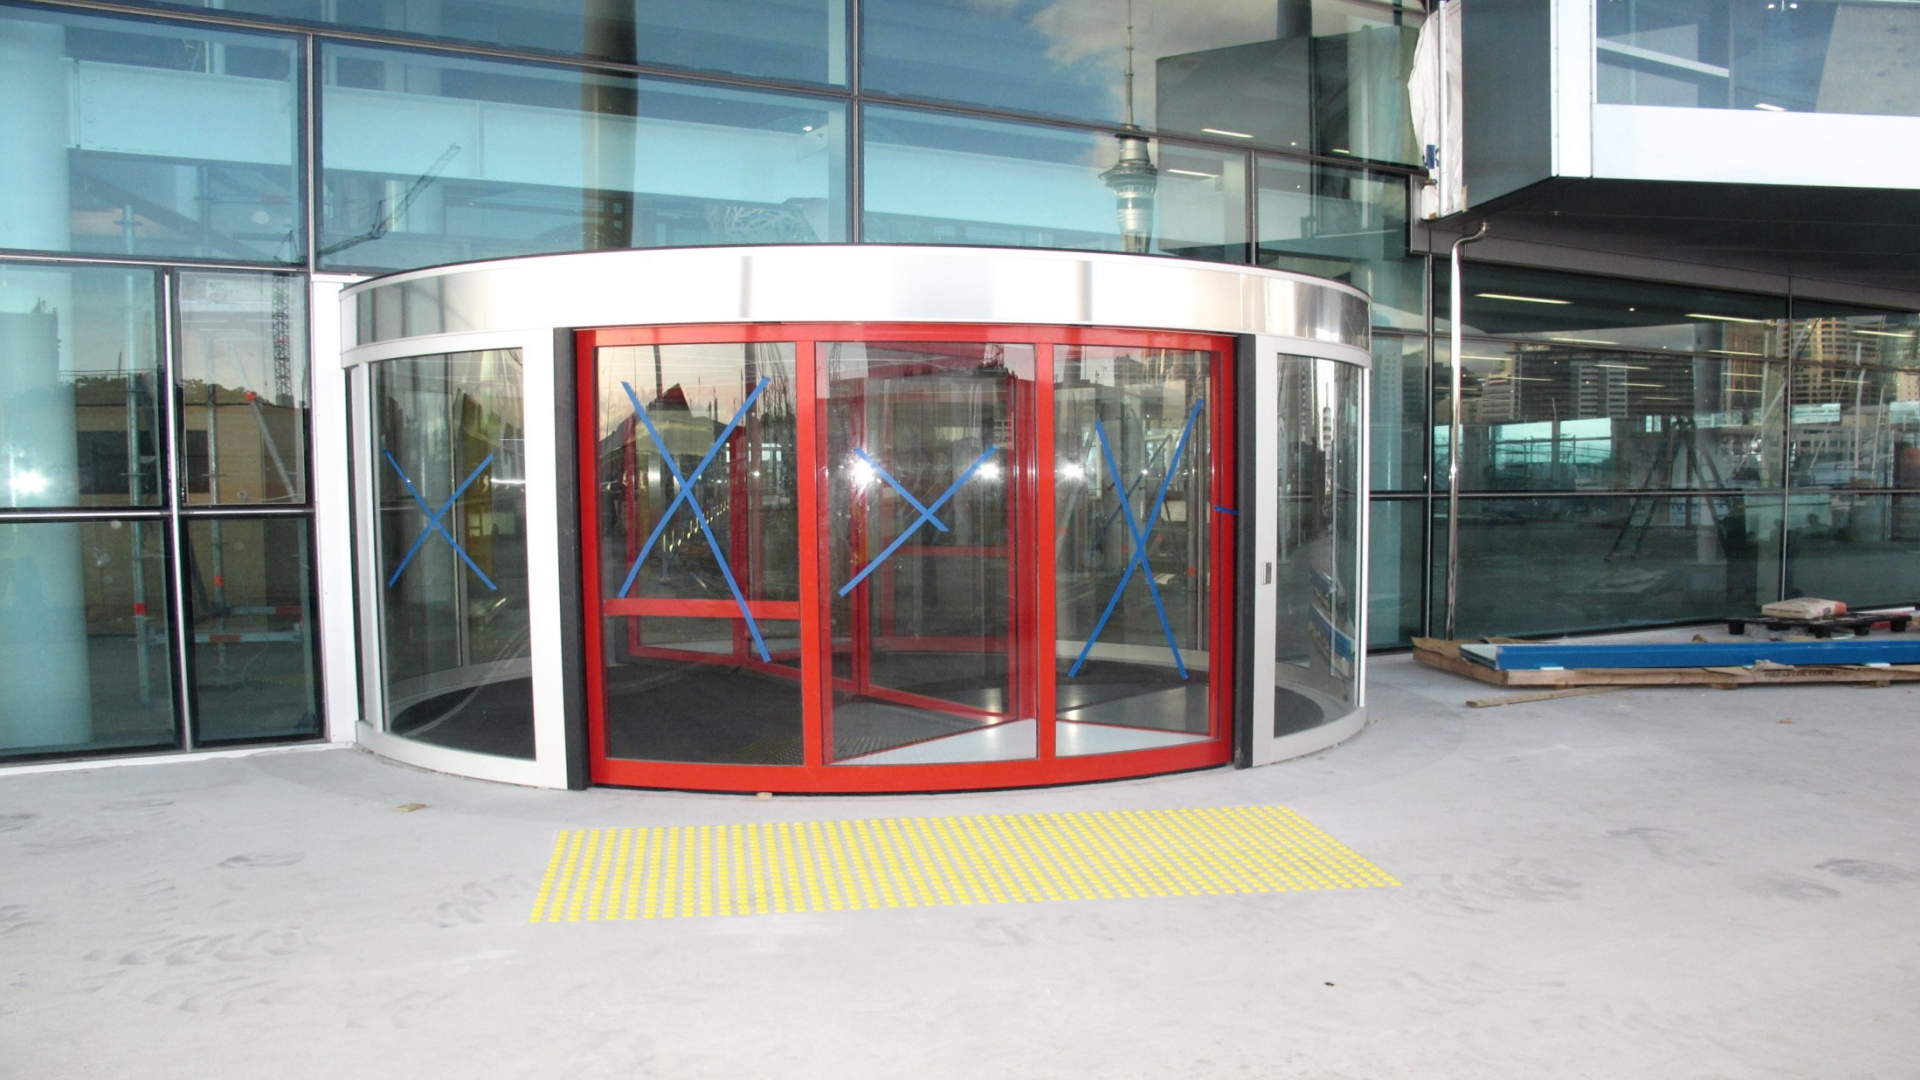
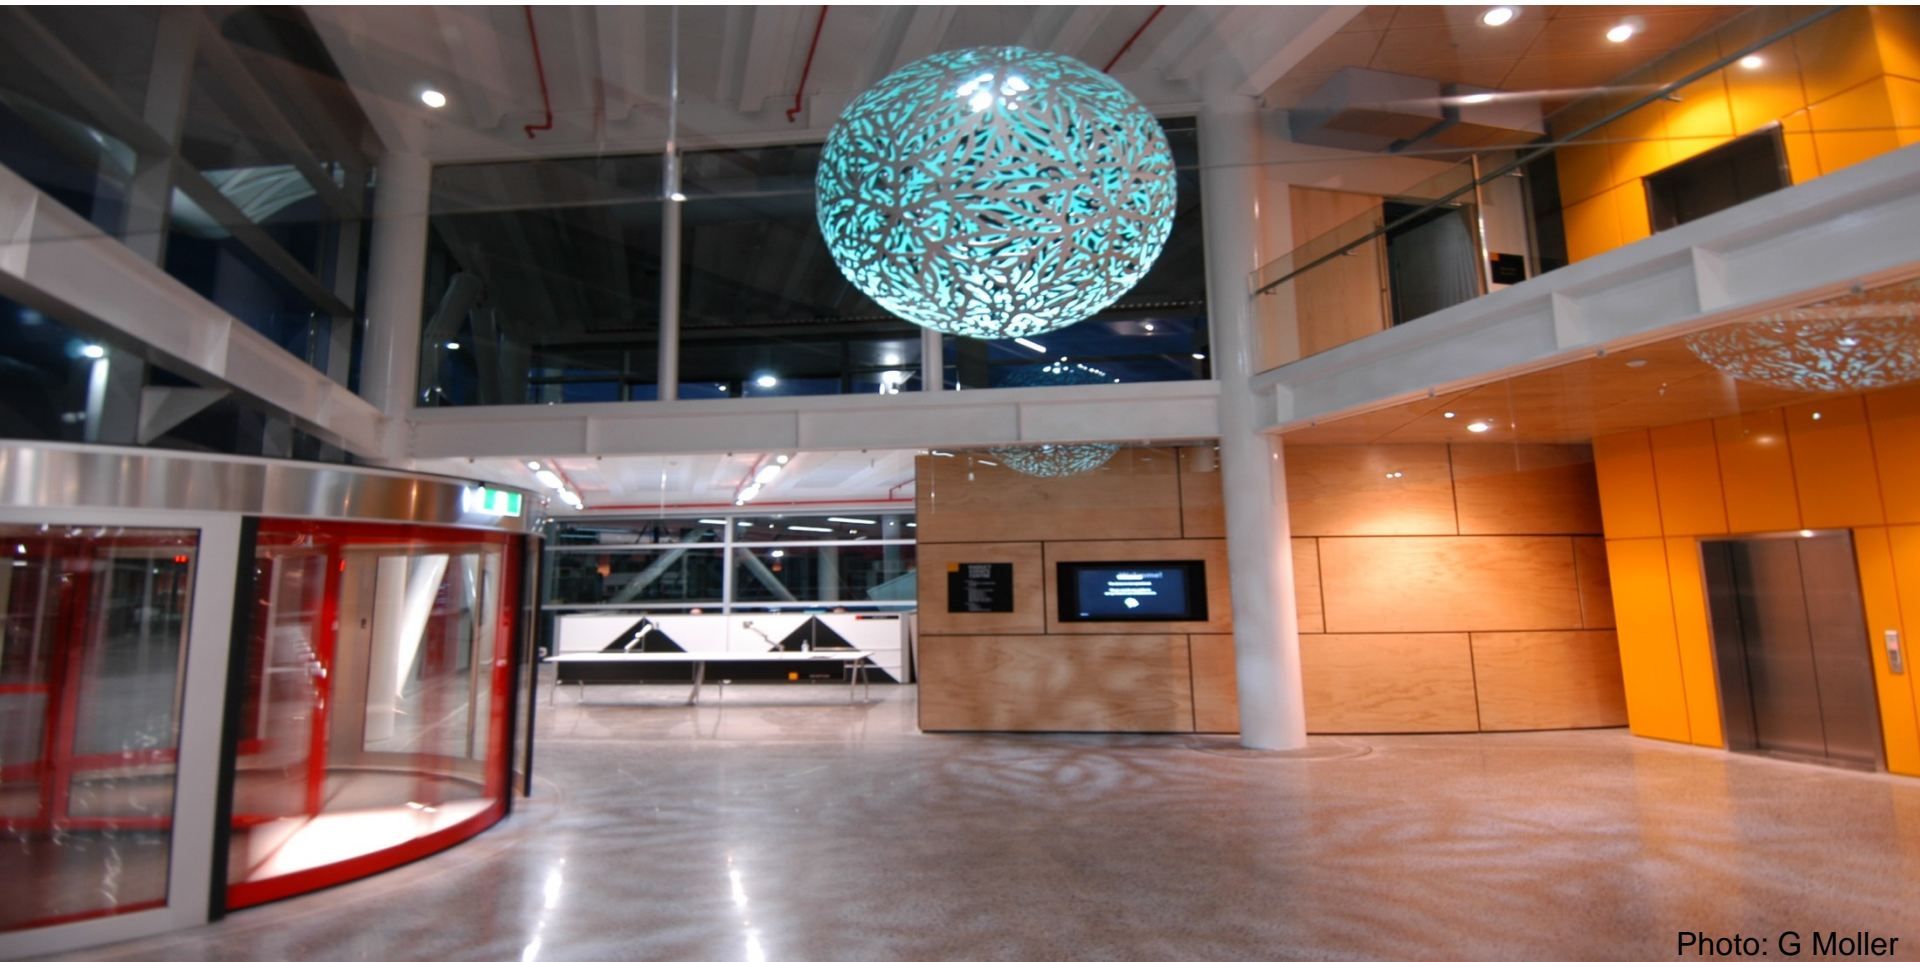
Accessibility Review of Uniturn Revolving Door

- Orientation – Prevent entry by mistake. **Tactile layout and entry alignment.**
- Sensors – Doesn't detect wheelchair. **Additional sensors to door areas identified.**
- Audible Warning – No audible cues. Doors silent in revolving motion but are audible in sliding mode. **Under review with Blind Foundation.**
- Visibility of Signage and Accessibility Push Pads. Poor button contrast. Signage not present to indicate that it is the main accessible entry. **Buttons or surround can be coloured and made larger.**

- Assistance dog reacted negatively to revolving doors. The accessible push pad has all options available, suggest that it is always set to sliding.
- Alternative entry point – Offer alternatives. An alternative entry point should be available for anyone uncomfortable with using a revolving door for any reason.
